Function and Use of a Nineteenth-Century Barn
"Walnut Hill" Estate
Pawling Road, Lower Providence Township
Montgomery County, Pennsylvania

A THESIS
in
The Graduate Program in Historic Preservation

MASTER OF SCIENCE
1991

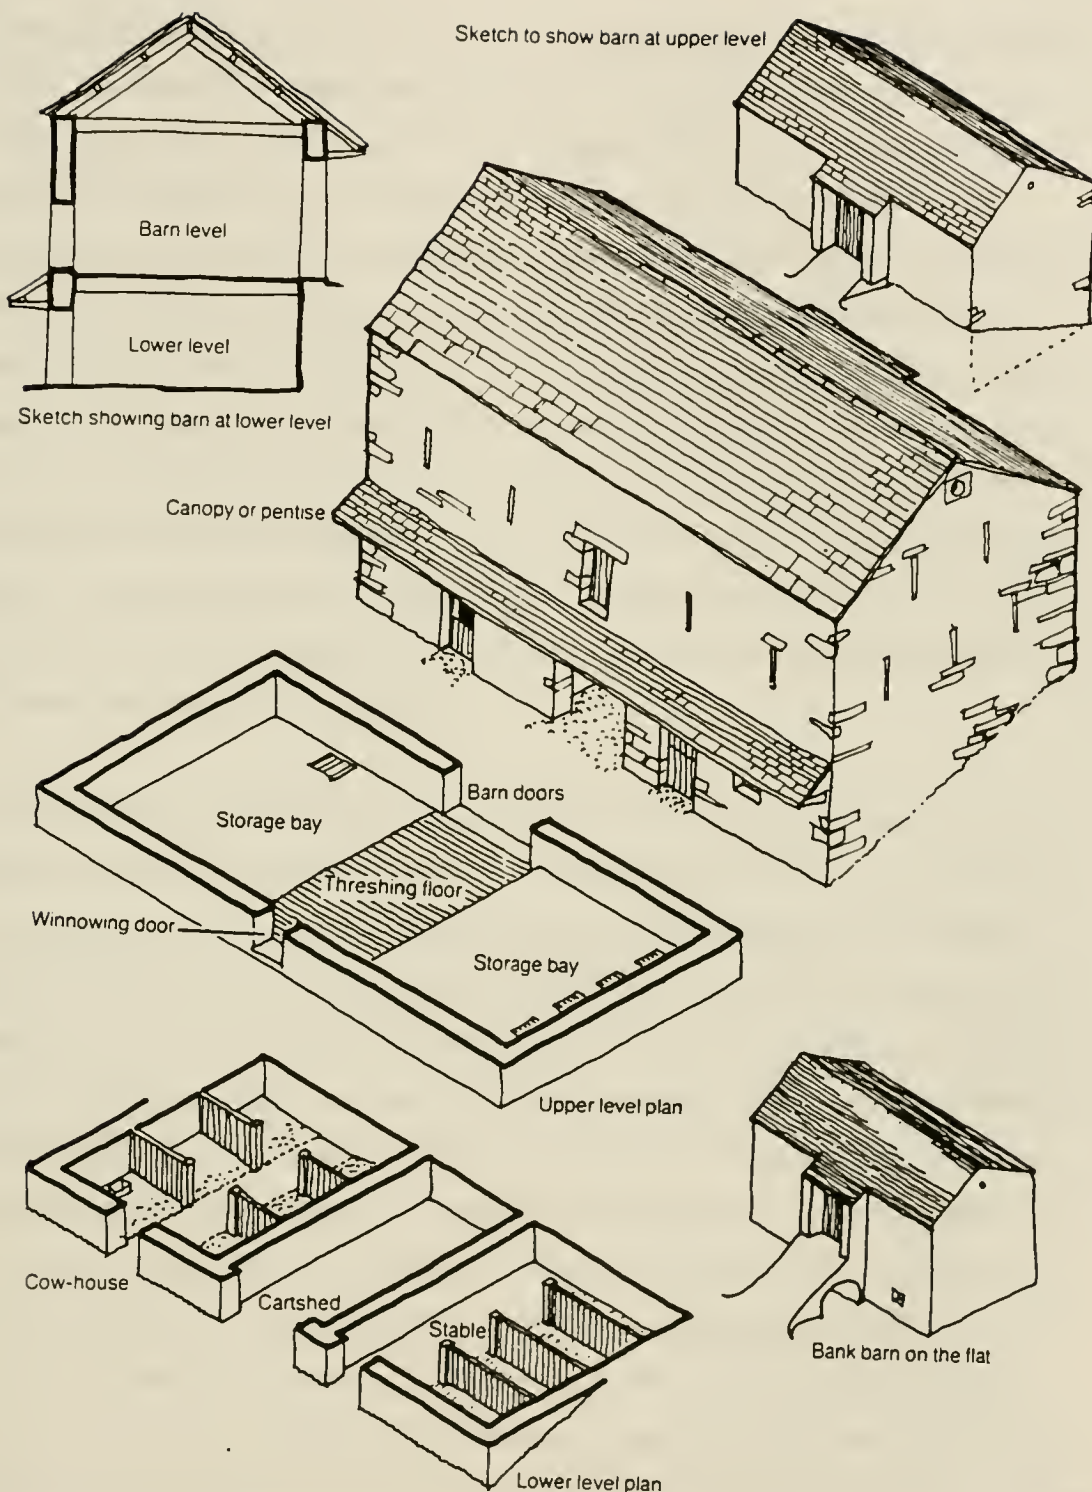
Figure 5: Isometric drawing of English bank barn showing floor plans, cross section and elevations. Illustration from R.W. Brunskill, Traditional Farm Buildings of Britain, London: Victor Gollancz Ltd., 1987, 114.

Counties due to its hilly terrain, with the main concentration in Cumbria, Pennine Cumbria, and the West Cumberland Plain (Plates 3-5).¹⁹ The principal farm buildings found in this region were the barn, cow-house, stable and granary, while the “bank barn” was a more specialized farm structure, mainly a development of the eighteenth and nineteenth centuries.²⁰ The English bank barn developed along parallel lines to the German-Swiss counterparts, and basically served the same purpose of consolidating mixed uses under one structure. Essentially, its design combined the traditional threshing barn with the cow-house and stable barns and was praised for “its compactness, its economy, and, very often, its rugged beauty.”²¹ The English bank barn was almost always situated along the contours of a natural or artificial slope.²² Its arrangement was similar to the German and Swiss types-- a ramp provided access to the upper threshing level and the lower level opened into the farmyard. The efficiency of its design saved on labor-intensive activities, in that the “unprocessed crops were hauled easily into the upper level and straw, or later hay, could be dropped through hatches into the cow-house and stable”.²³ The arrangement of the upper level was composed of a central threshing floor and large barn doors opening outwards at the head of the ramped rear entry. The doors were usually protected by a canopy and sometimes incorporated projecting wings, or “outsheds”, to each side of the ramp. A “winnowing” door was located at the opposite end of this opening, placed high up on the wall.²⁴ Upper windows generally consisted of ventilation slit openings. The lower level combined several different functions together. Access to a cart shed, generally located directly below the threshing floor, was flanked by a cow-house and stable. In place of the typically Swiss “forebay”, the English bank barn employed a small cantilevered canopy, or pent roof, over the stable doors (Fig. 5).²⁵

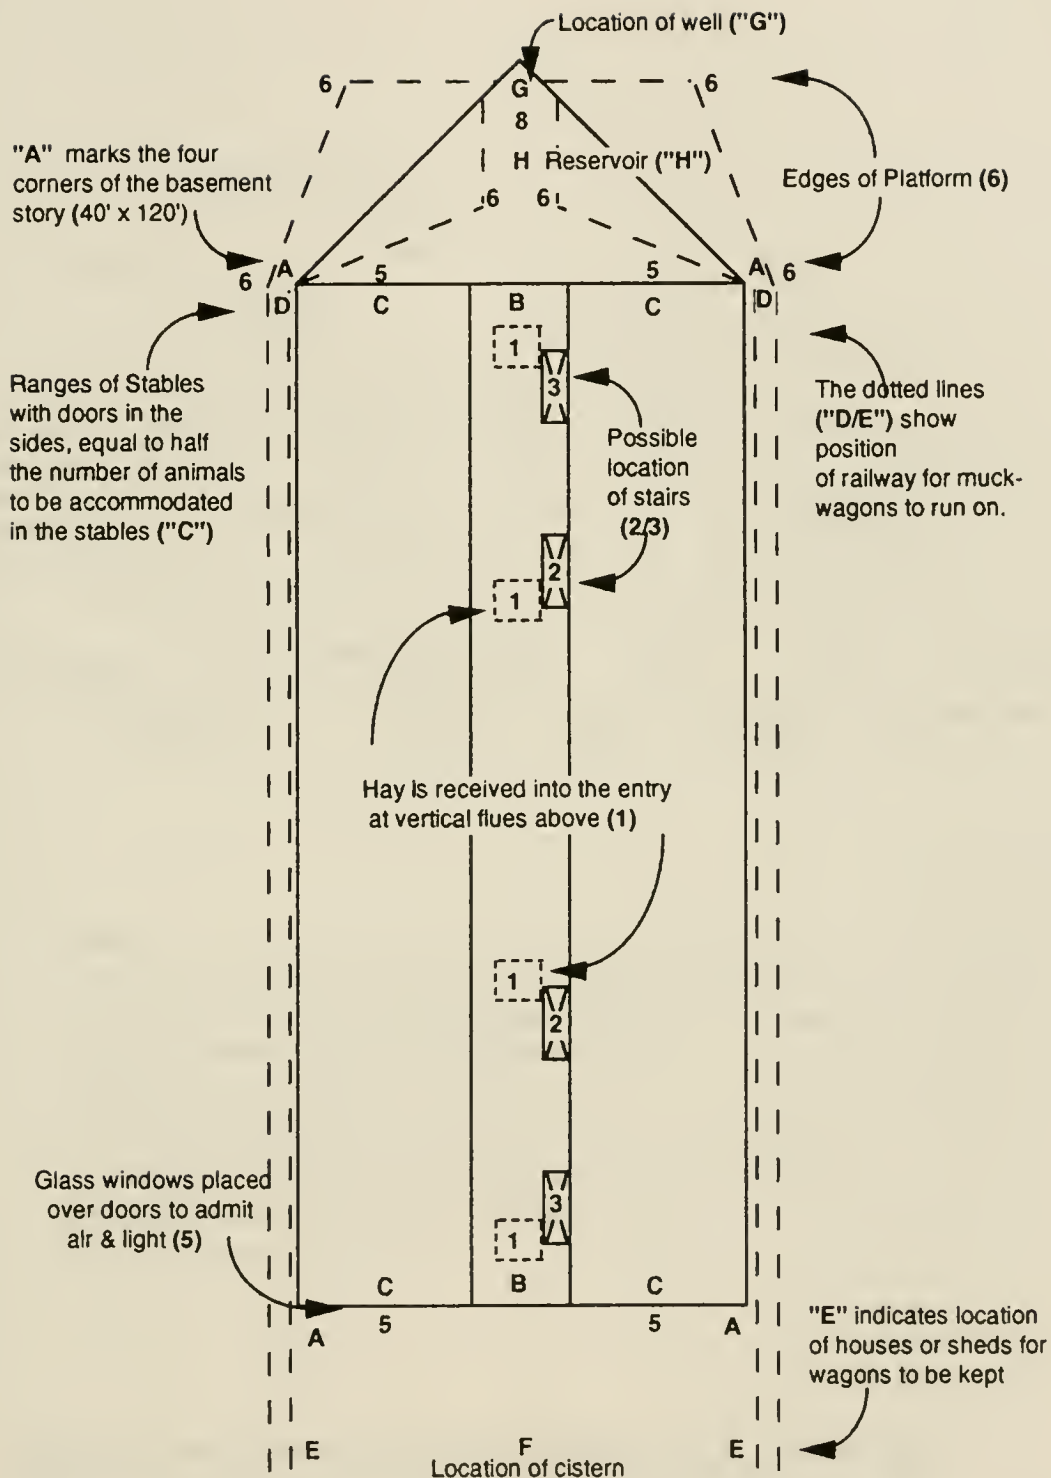
Figure 7: Basement floor plan showing efficient layout of stable area. From "Remarks upon Agricultural Buildings. No. 3. Barn and Stabling," *The Farmer's Cabinet*, Volume II, August 1837-July 1838, Philadelphia, PA: John Libby Publishing, 1838, 181.

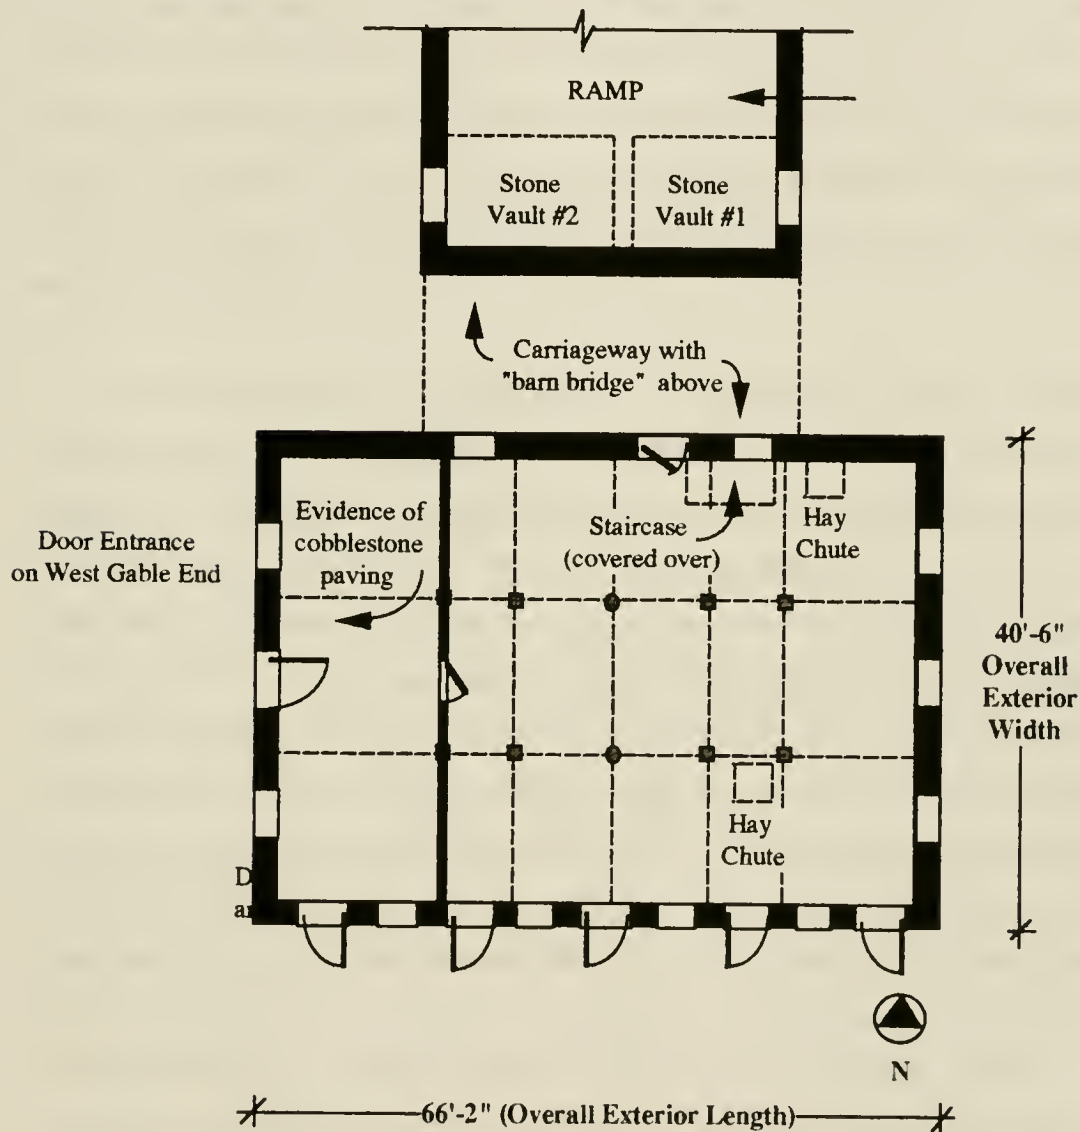
Figure 11: 1826 Ground Floor Plan of Walnut Hill barn (not to scale)

The interior arrangement of the 1826 barn consisted of stables at the lower basement level, grain storage at the middle level, and the threshing platform and hay mows at the third level. The stables were sheltered on the north side by the bank and, most likely, opened to an enclosed farmyard along the south elevation. This open corral served as a place to exercise and water the animals, and collect their dung. As cited in the previous chapter on Pennsylvania barns, John Nicholson, an early writer on the subject of agricultural practices, recommended the construction of a high fence to enclose a section of the barnyard. The ground should slope slightly, with the lowest area in the middle to collect the manure, which could then be spread on the fields as fertilizer. Nicholson also mentioned that a well should be nearby to supply water for the cattle.¹⁵

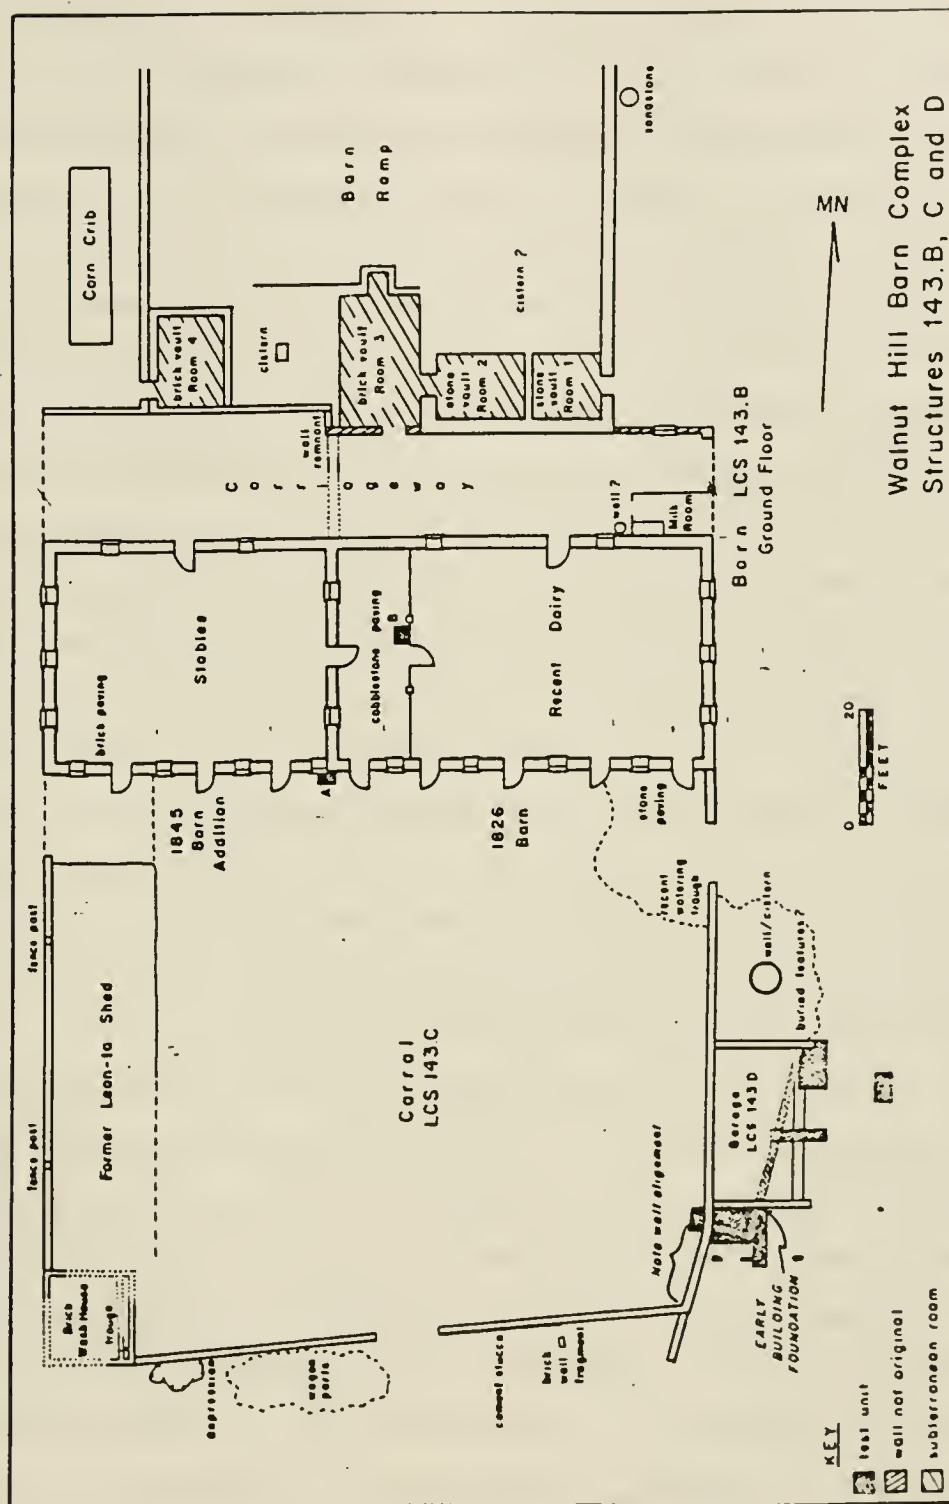
Figure 12: Plan of Walnut Hill complex showing archaeologists's test units. James E. Kurtz, "Archaeological Survey and Assessment: North of the Schuylkill River," (Draft), U.S. Department of Interior, National Park Service, 1988.

An enclosed farmyard area, consisting of a low stone wall on three sides, extended from the south elevation and created an open area for the animals to feed (Fig. 12). An opening was centered on the south stone wall, and other openings were provided along the side walls (east and west) near the barn. The west wall has several pocket openings for joists, located approximately 2 to 3 feet above ground level (Plate 28). Nine pockets are evident in the stonework and appear to be found every 3 to 4 feet apart. The northwest section has remains of a concrete foundation, about 4 feet by 10 feet. In the southwest corner, a brick foundation wall is visible as well as remains from a concrete trough. Concrete slabs are located in the ground across most of the length of this wall, except where the concrete foundation and brick foundation wall is located. It is difficult to determine what was original and what portions were later additions. There is also a trace of a previous gable roofline evidenced in the stonework at the west end of the barn wall, which extends to the top of the middle level window. This is the remaining visual evidence of the gable building that once stood along this west wall. A photograph taken in the 1940s by Charles Dornbusch shows a two-story wood building, or "straw shed", that existed along this wall (Plates 23 & 25). The east stone wall has a small section that extends approximately

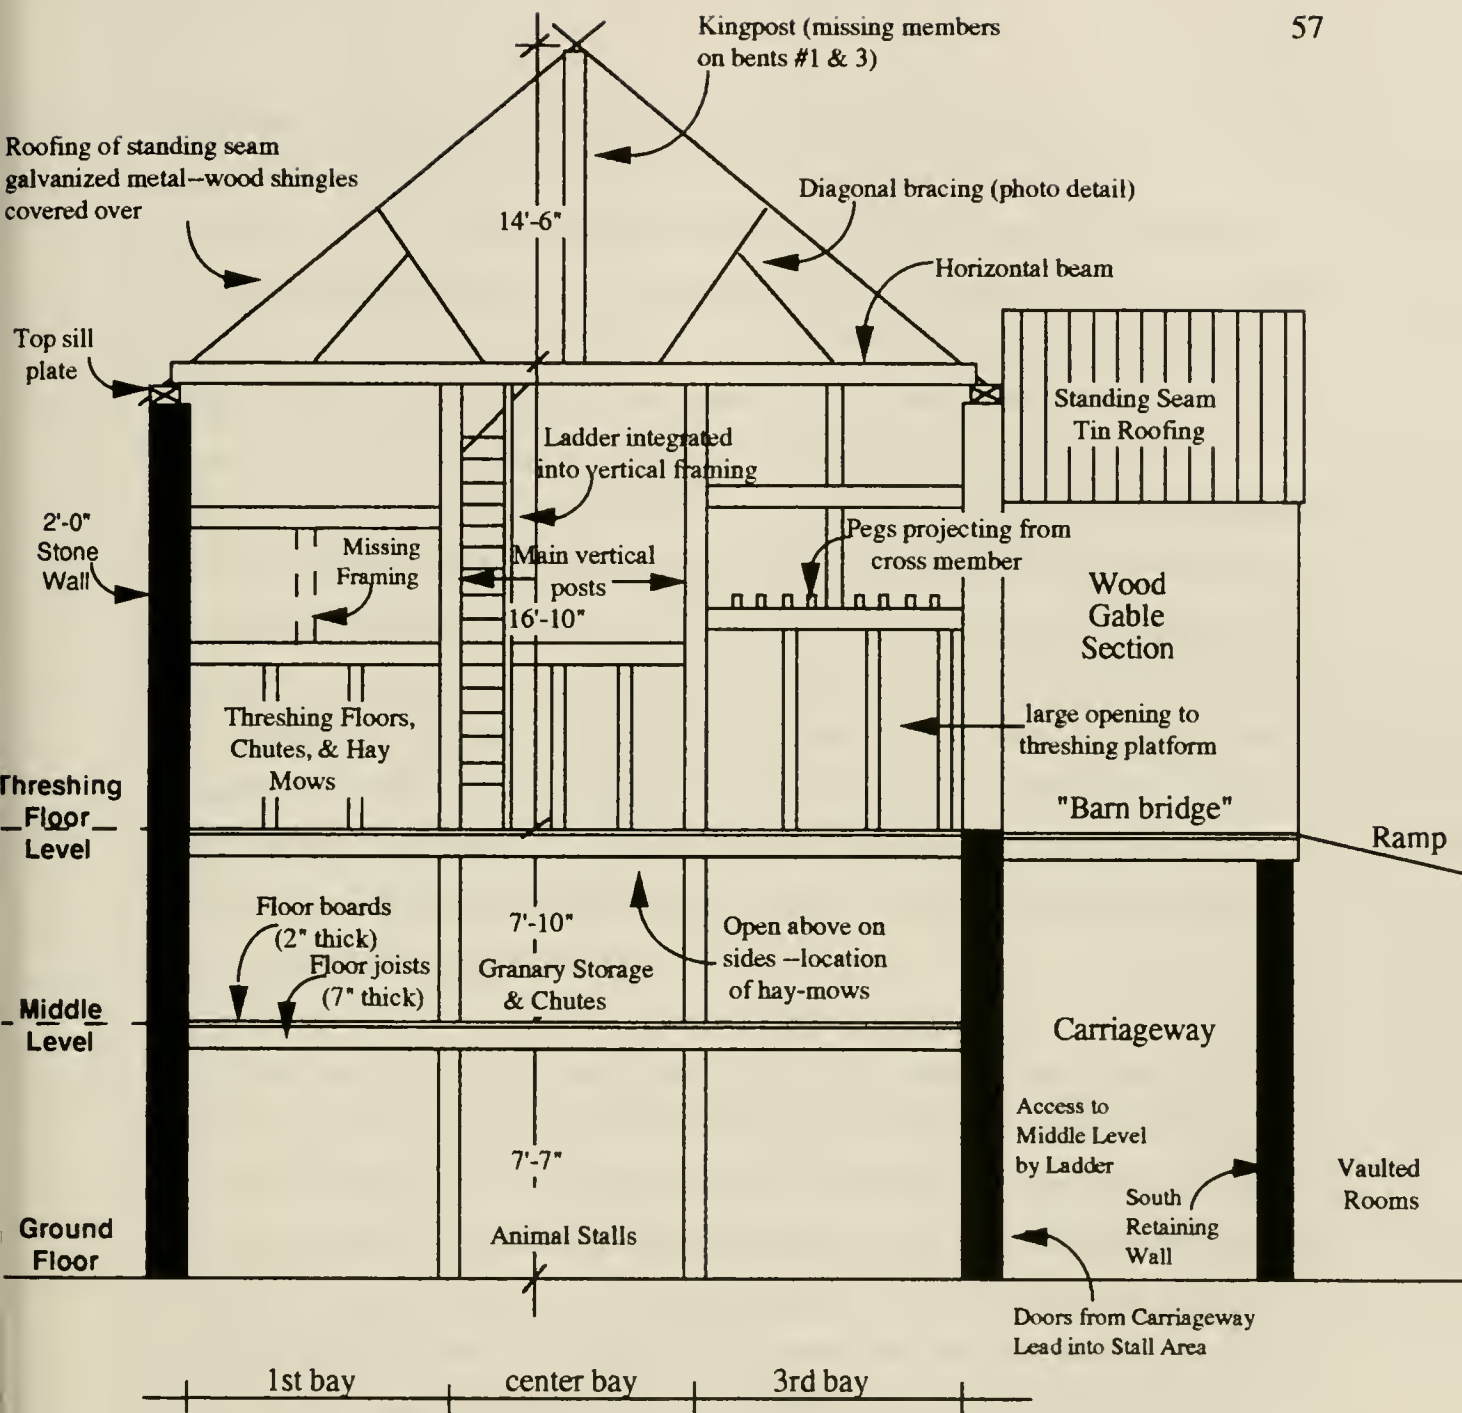
Figure: 13 1826 Section of Walnut Hill barn showing cross section of typical bent (not to scale)

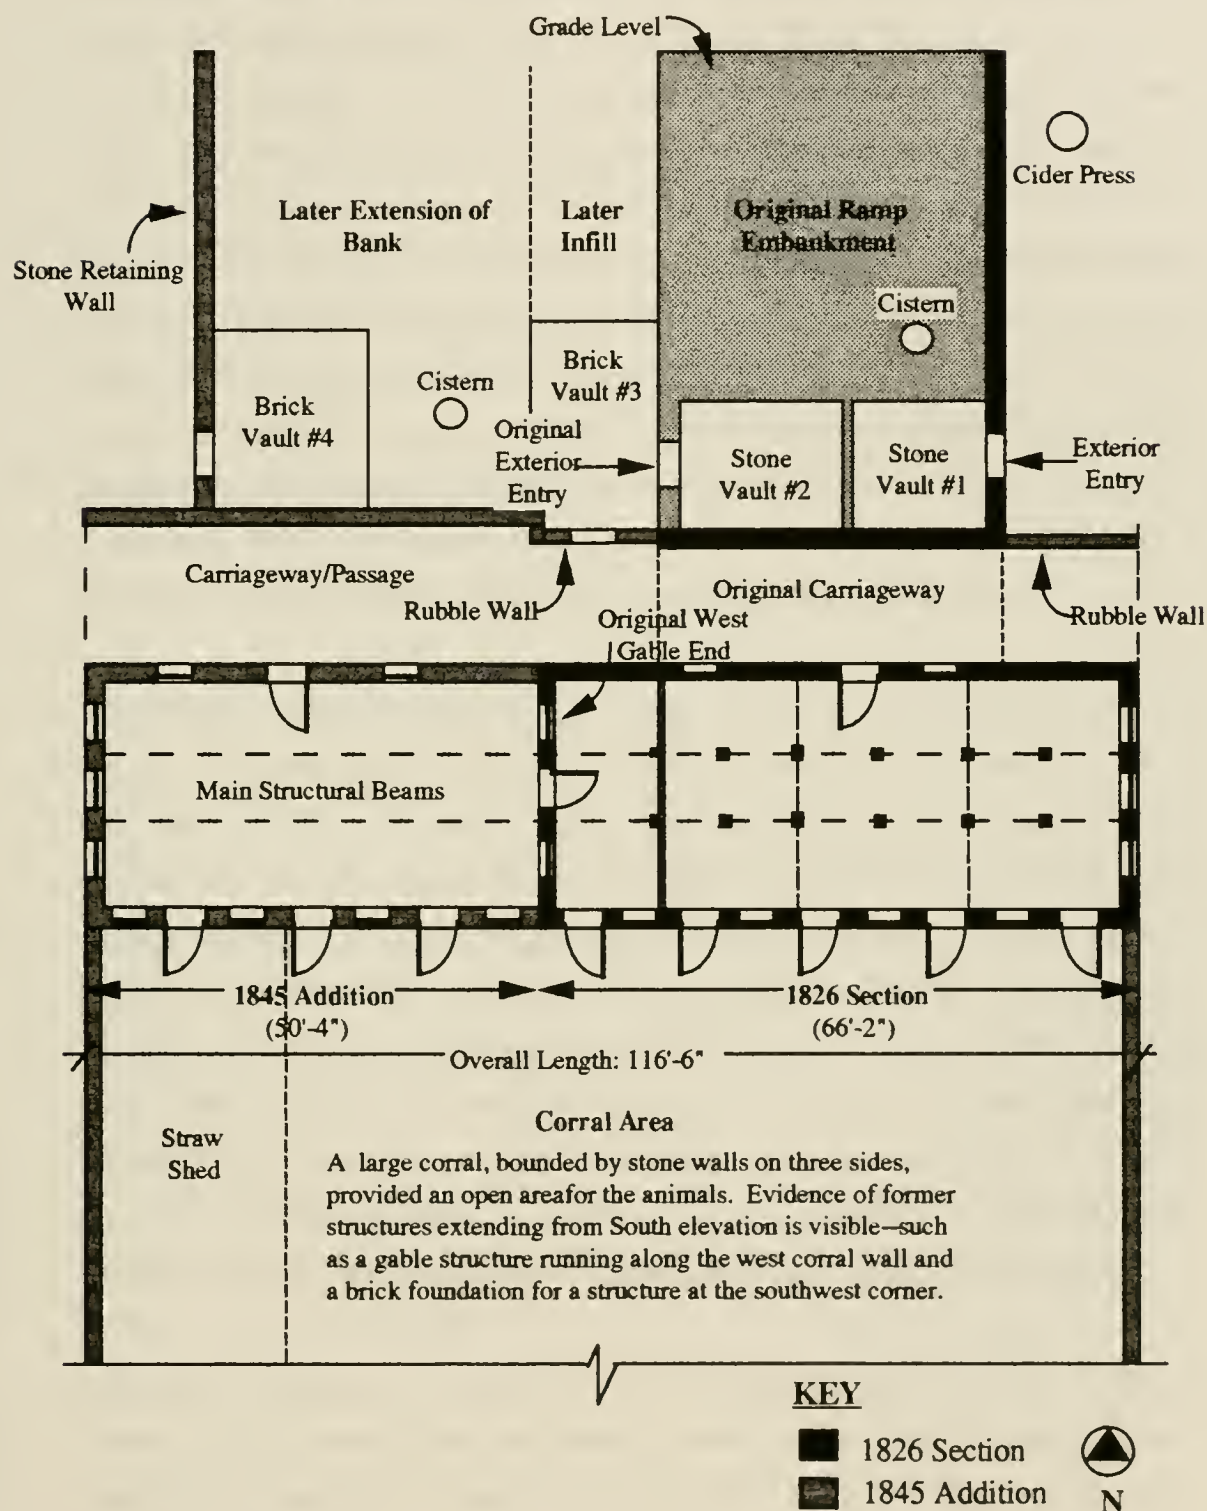
Figure 14: Overall Ground Floor Plan of Walnut Hill barn (not to scale)

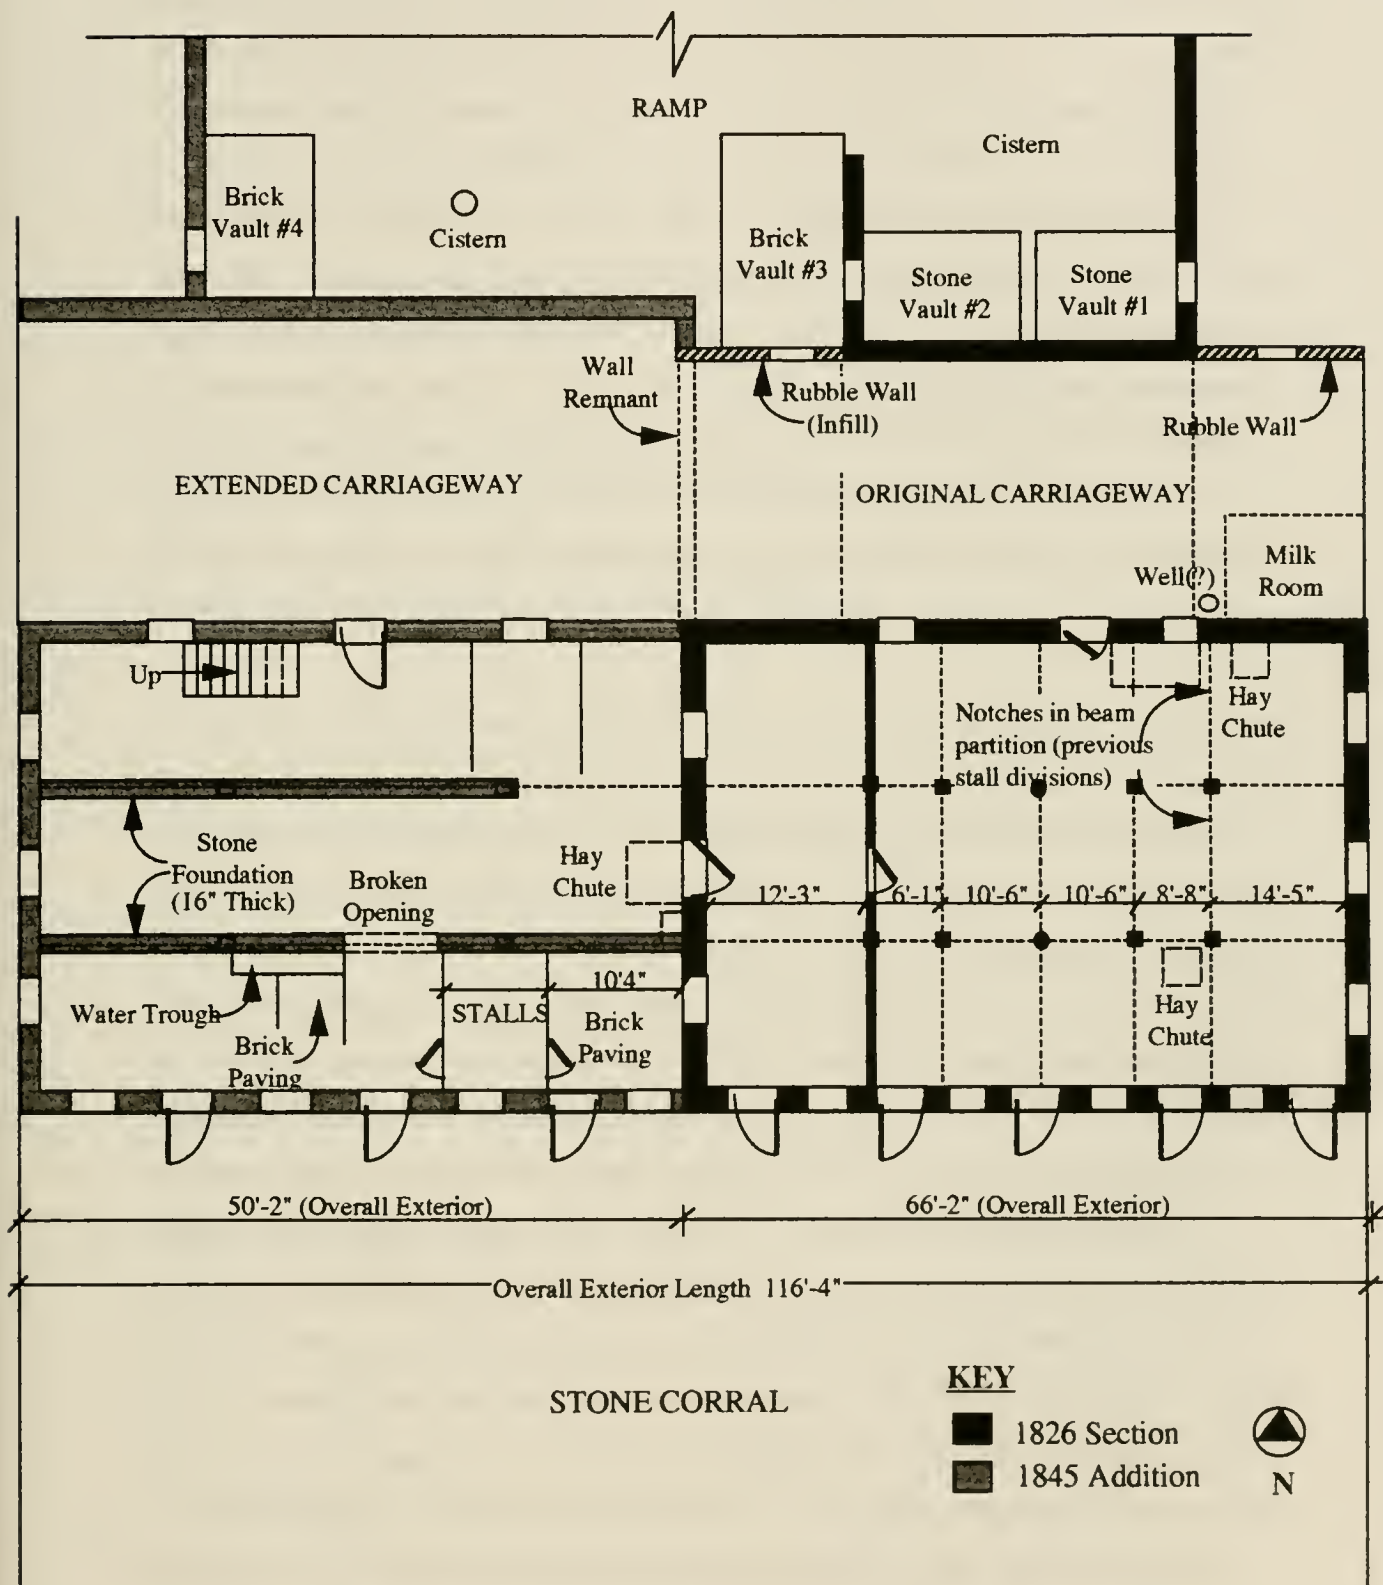
Figure 15: Ground Floor Plan of Walnut Hill barn (not to scale)

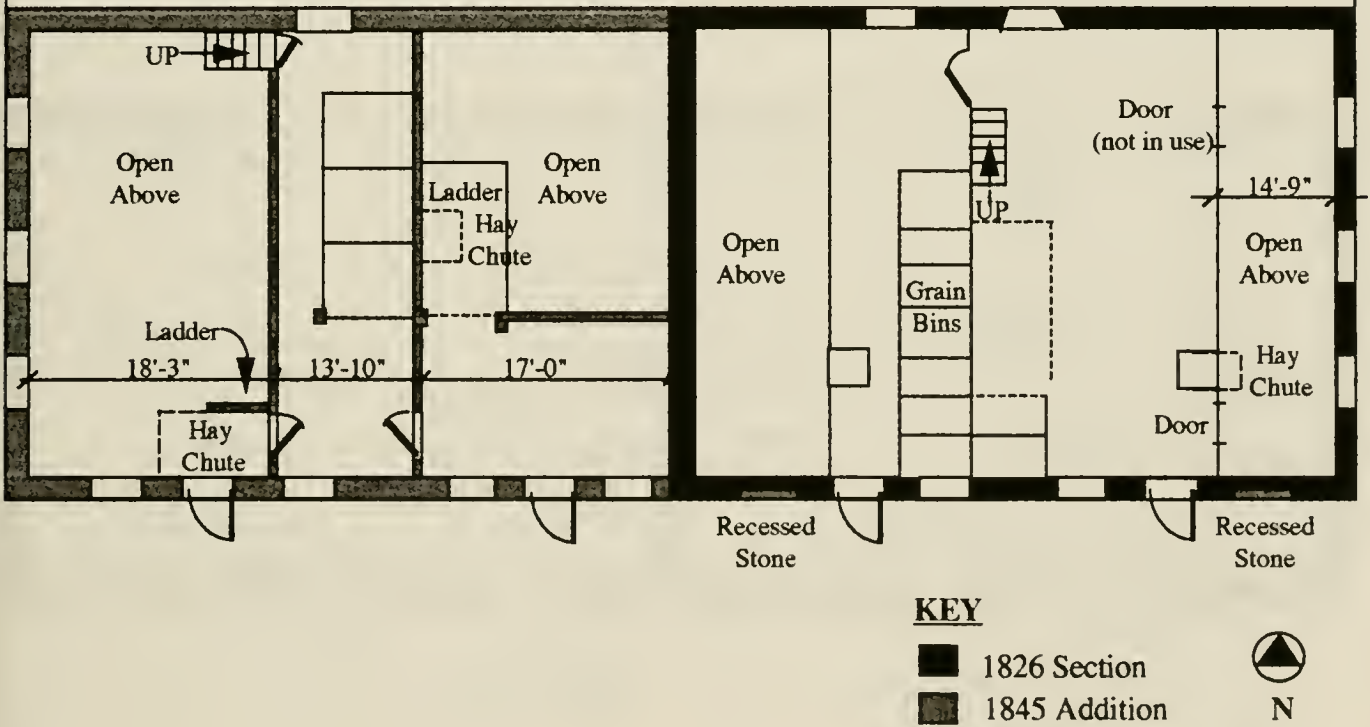
Figure 16: Middle Level, or Granary, of Walnut Hill barn (not to scale)

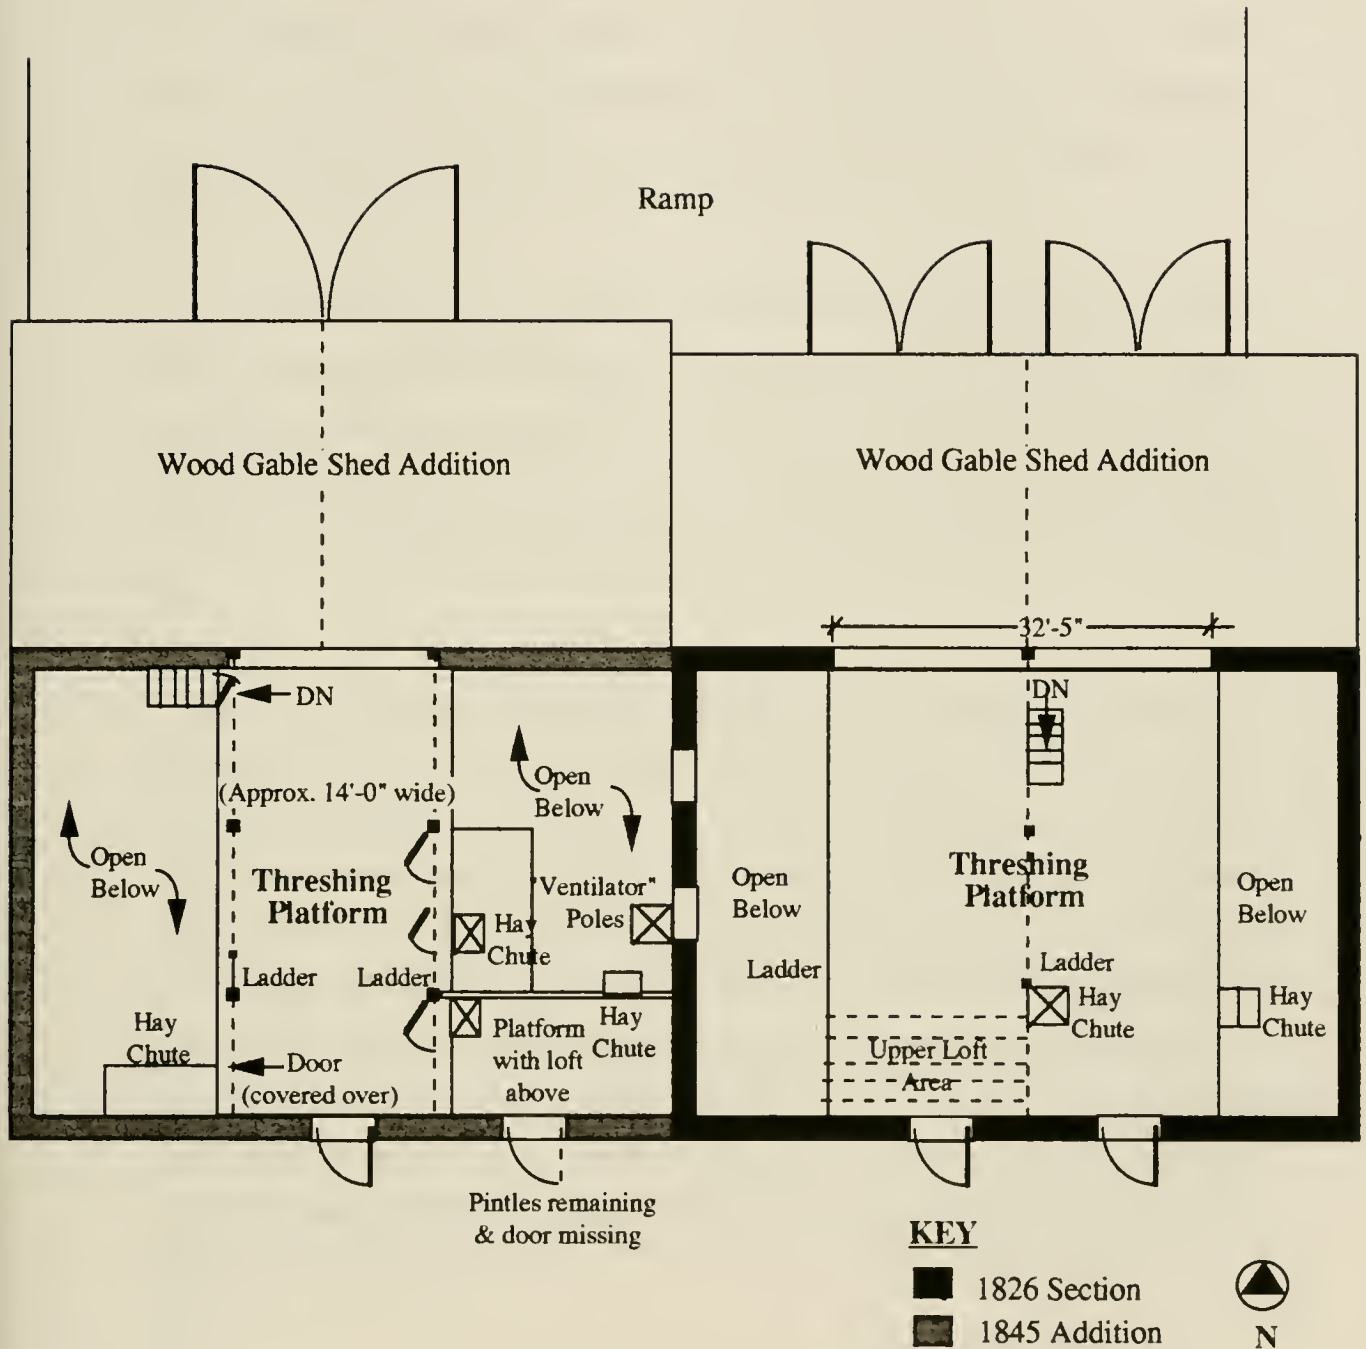
Figure 17: Third Level, or Threshing Floor, of Walnut Hill barn (not to scale)

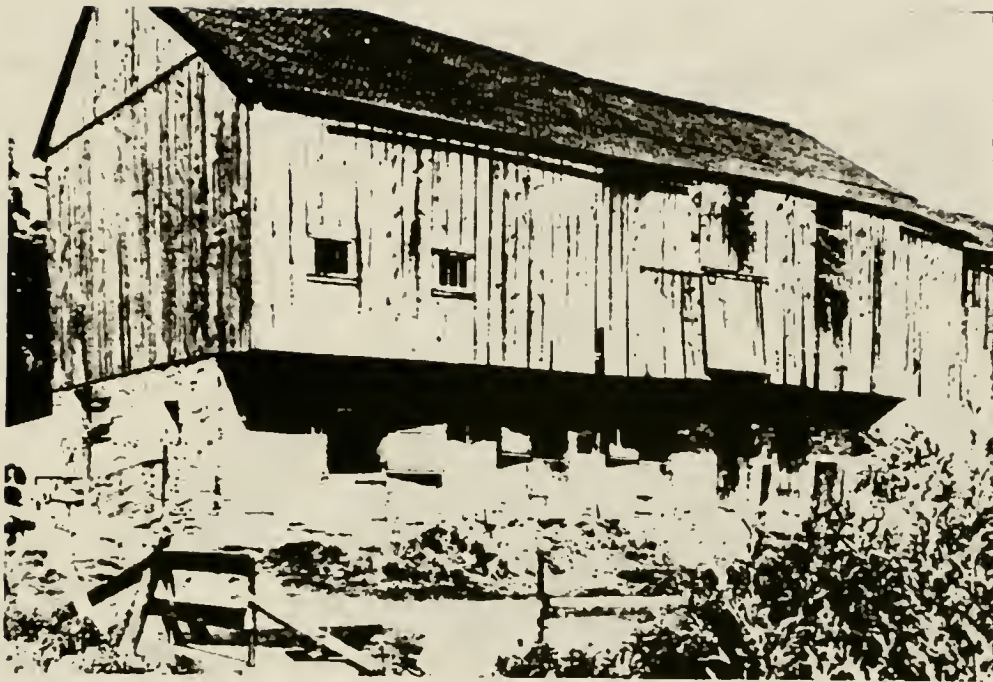
Plate 1: Example of a "Sweitzer" bank barn near Fogelsville in Lehigh County, PA. Shows the wood "forebay", or overhang, at upper level and the stone construction below where the stables are located. Charles Dornbusch, *Pennsylvania German Barns*, Volume 21xxi (Allentown, PA: Pennsylvania German Folklore Society, 1958), 81.

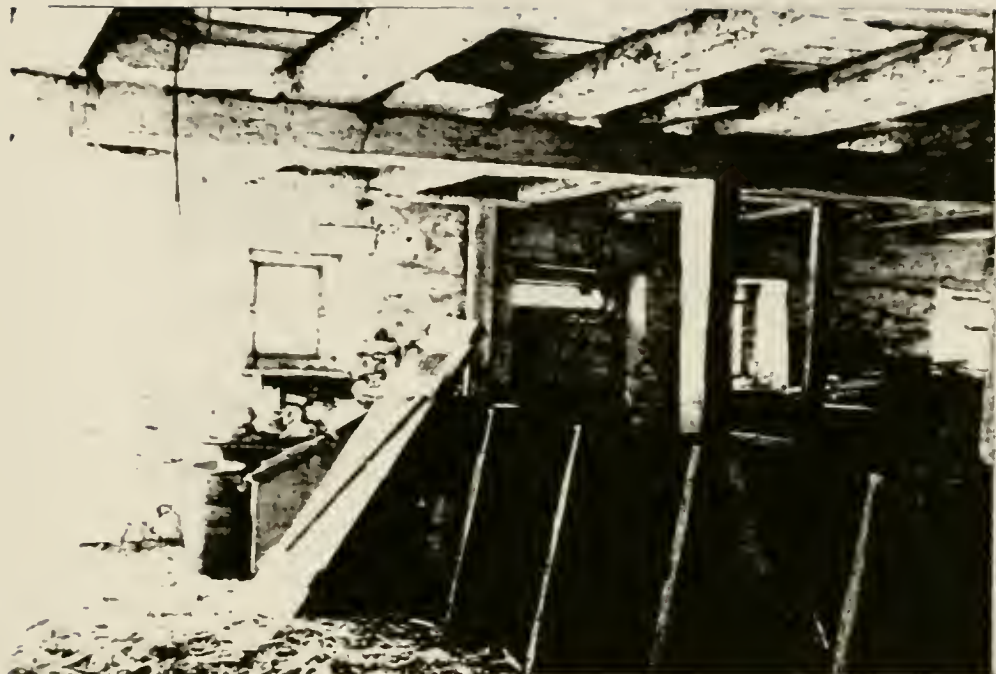
Plate 2: Interior of a barn in Lancaster County, PA (1804) showing typical stall arrangement at basement level. Framing of the structure consists of squared timbers running lengthwise and dressed vertical columns. Coat of lime whitewash keeps livestock area sanitary. Sloping bins on right are mangers for the cattle; aisle for feeding service located beyond first tier. Charles Dornbusch, 137.

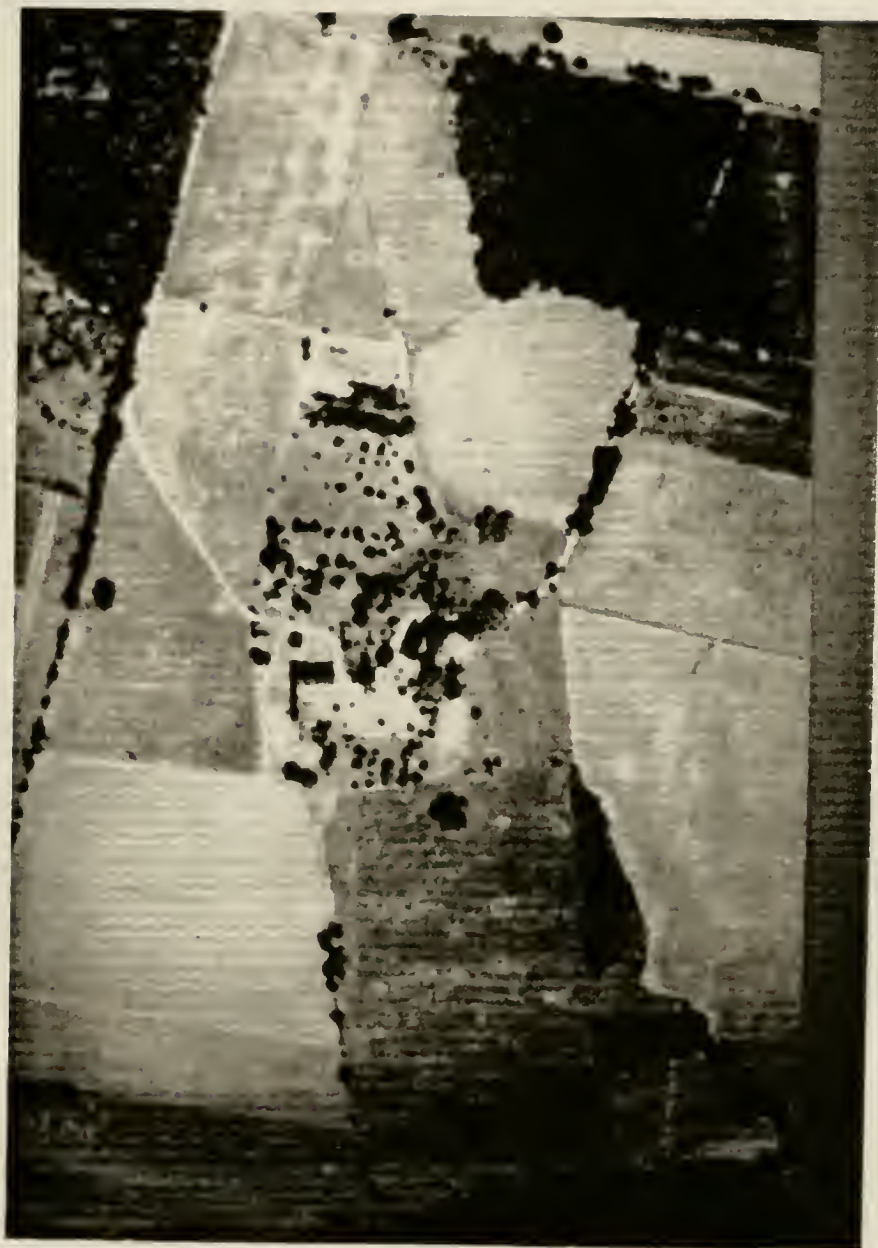
Plate 6: Aerial view of Walnut Hill Farm, circa 1970. Valley Forge National Historical Park Files, Administration Building, Valley Forge, PA.

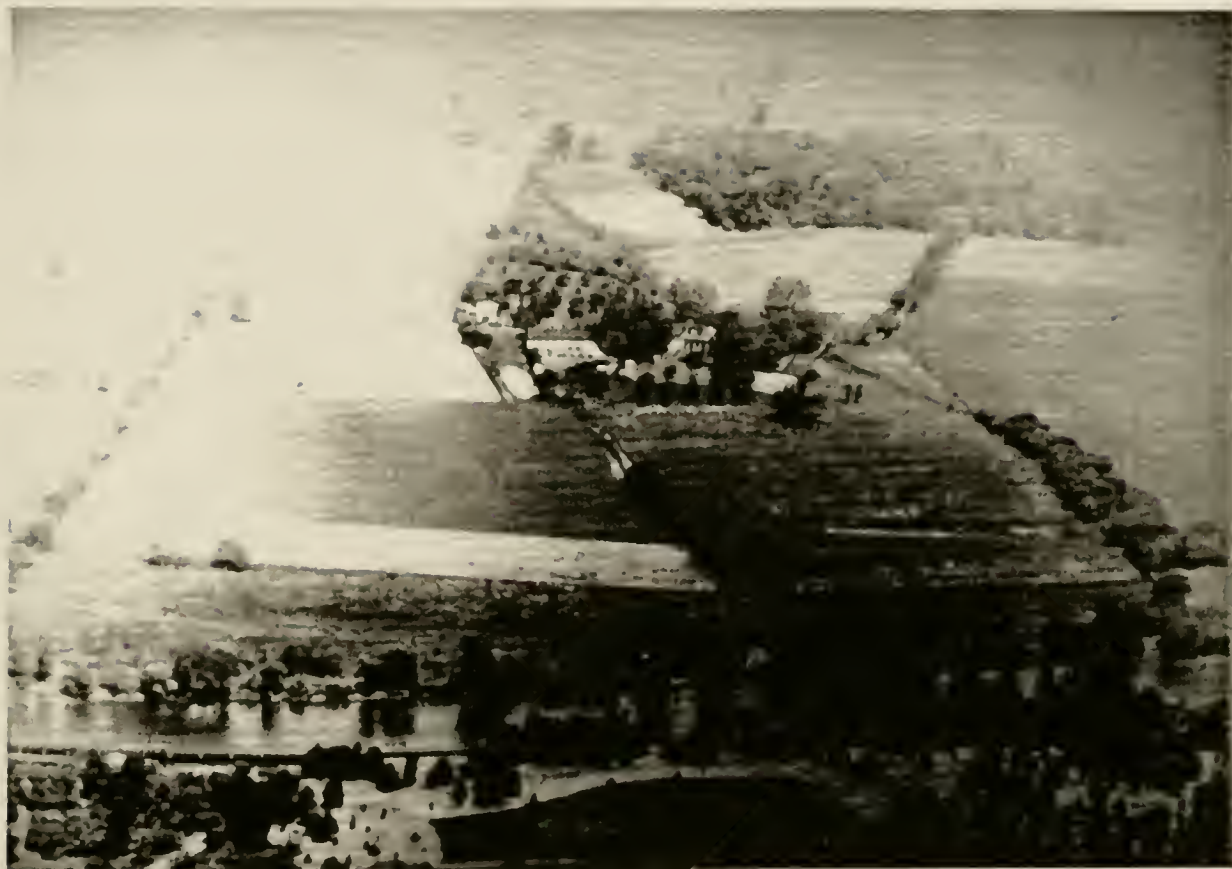
Plate 7: Aerial view of Walnut Hill estate showing location of mansion (right) and barn (left). Shows barn with shingled roof and shed addition along west corral wall. Valley Forge National Historical Park Files, Administration Building, Valley Forge, PA.

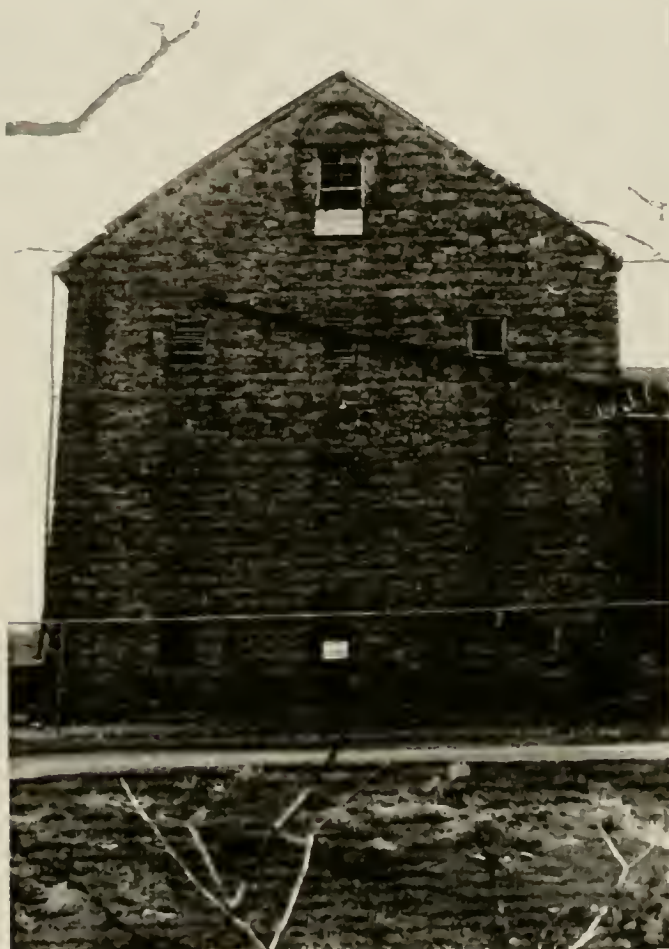
Plate 12: Close-up of east gable end showing symmetrical layout and recessed stone panels at middle level

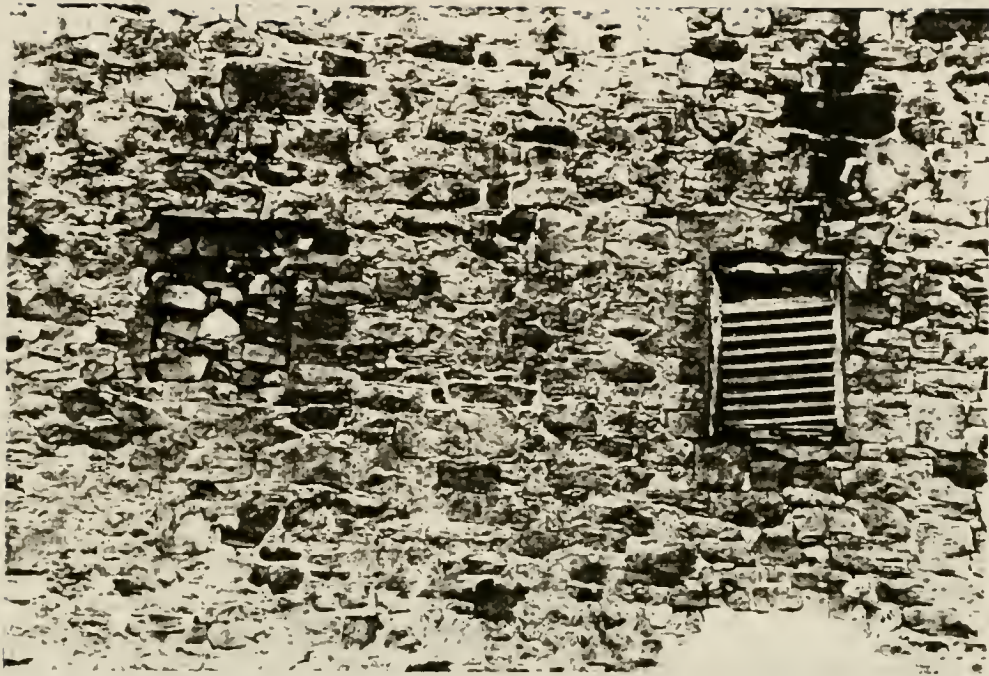
Plate 14: Detail of east gable end stone recessed panels and louvered frame to disguise false opening

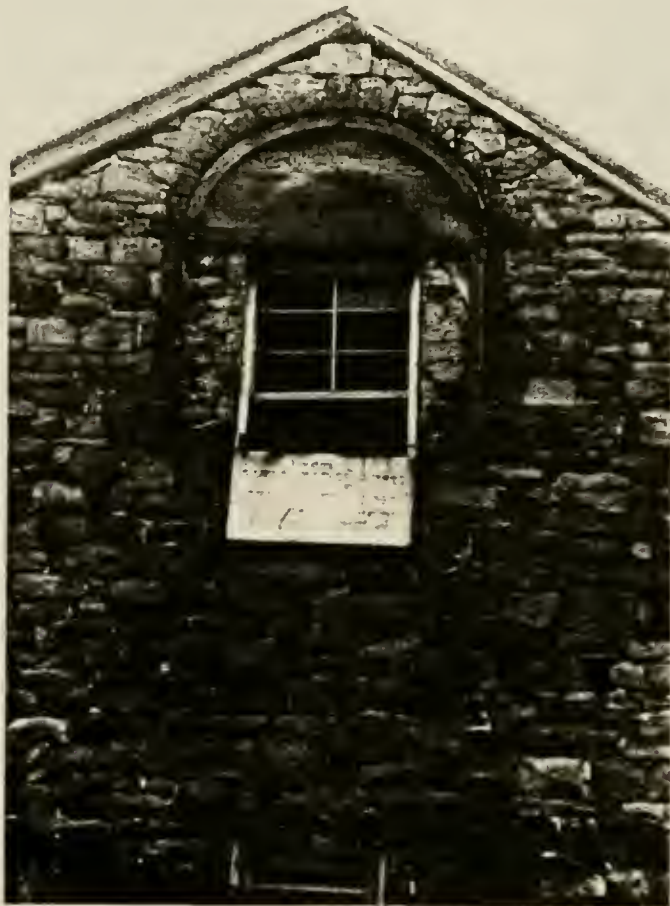
Plate 15: Detail of window in gable end of east elevation with datestone incorporated below

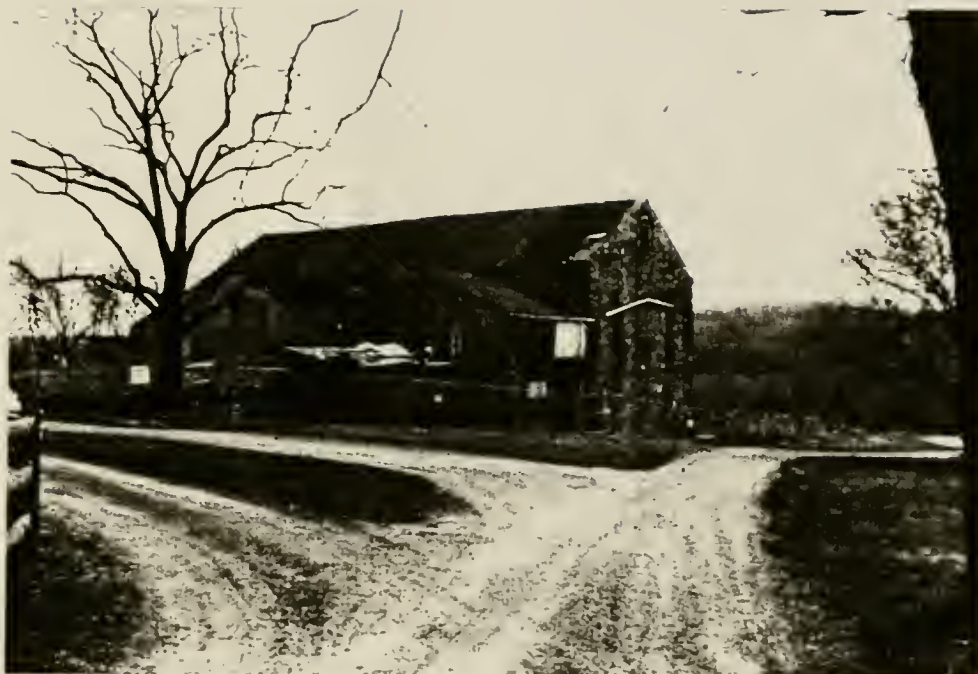
Plate 16: View of working drive looking south, showing rampway along north elevation of barn and west gable end of 1845 section.
